## Flexural Behavior of Corroded Steel Fiber Reinforced Concrete Beams with Variable Fiber Contents

### Abstract

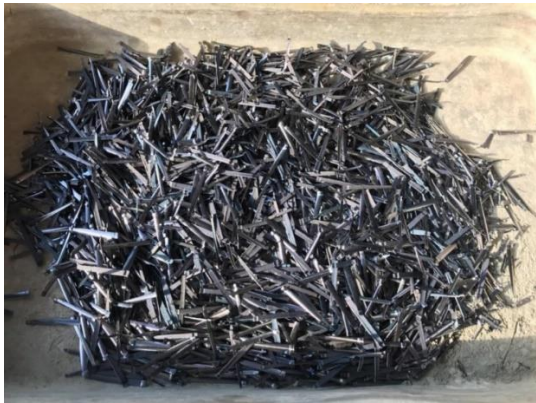
**Fig. 2** Mill-cut steel fibers with hooked ends [3]

The mill-cut steel fiber with hooked ends as shown in Fig 2 was used in this study. It had a length of 32 mm and a width of 2.6 mm. The properties of mill-cut steel fiber are tabulated in Table 3.

Length, l (mm)	Width, d (mm)	Aspect ratio l/d	Tensile Strength (MPa)	Specific gravity
32.0 ± 2.0	2.6 ± 1.2	35-45	≥ 700	8.9

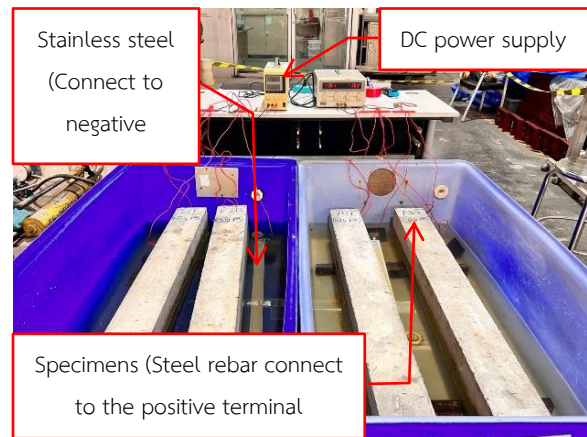
**Fig. 3** Acceleration corrosion set up.

After complete curing procedure, the specimens were induced corrosion. The impressed current technique (ICT) was used to accelerated corrosion, so that, the corrosive specimens could be completed within a reasonable amount of time. Corrosion is induced by applying an electrochemical potential between the steel reinforcement and a cathode. These beams were immersed in a 3% sodium chloride solution at a depth covered the tensile steel bars. This condition ensures that the beam is in a saturated state by admitting both oxygen and moisture. A water tank was constructed for the ICT facility, which

is seen in Fig 3. The steel bars were connected to the positive terminal of the DC power supply, while the negative terminal was connected to a parallel-positioned stainless-steel bar. In addition, to confirm the constant current induced to the specimens, the multimeter was used for measuring the current during the tests as displayed in Fig. 4.

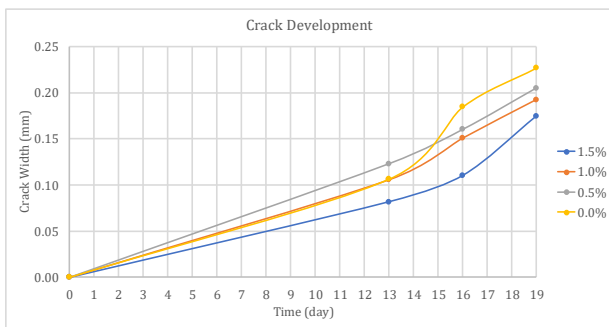
Fig. 10 Crack propagation of all beams

Figure 10 shows the average crack widths from three sides of the beam (left, right, bottom) from each recording date. The results from the beams with various amounts of fiber volume were compared. By considering maximum crack width at the last date, the crack widths significantly reduced from 0.20mm to 0.17mm for RC beam (C19F0) to the 1.5% SFRC beam. The tendency of crack width reducing with higher amount of fiber volume had shown in every recording date which performed the high performance to restrain the crack opening with the more fiber volume in the beam. In Fig. 10, all average results of crack width were plotted to observe the effect of fiber volume to the crack propagation. The cracks propagation during the corrosion acceleration period was reduced with higher fiber volume. Especially, the significant reduction of crack opening presented in the highest amount of fiber beam. It is noticed that the steel fiber works perfectly to reduce the crack development compared to RC beam.

1. The use of steel fiber greatly reduced the cracks in beam C19F0, C19F0.5, C19F1.0 and C19F1.5 by 0.23mm, 0.21mm, 0.19mm and 0.17mm respectively. Moreover, by adding higher amount of steel fiber, the crack propagation in the SFRC beam develops slower than RC beam.
2. The yield and ultimate load capacity of SFRC beams significantly increase with the rising volume of steel fiber. The yield capacity of beams C19F0.5, C19F1.0, and C19F1.5 increased by 6%, 9%, and 9% compared to RC beam, respectively.
3. Steel fiber significantly contributes ductile behavior of the beams and maintains the stable load resistance although beyond the yielding load stage.
